Standard Guide for Selection of Structural Details for Ship Construction¹

The principal aim of this guide is to depict recommended practices related to the design of ship structural details. The importance of structural details is clear:

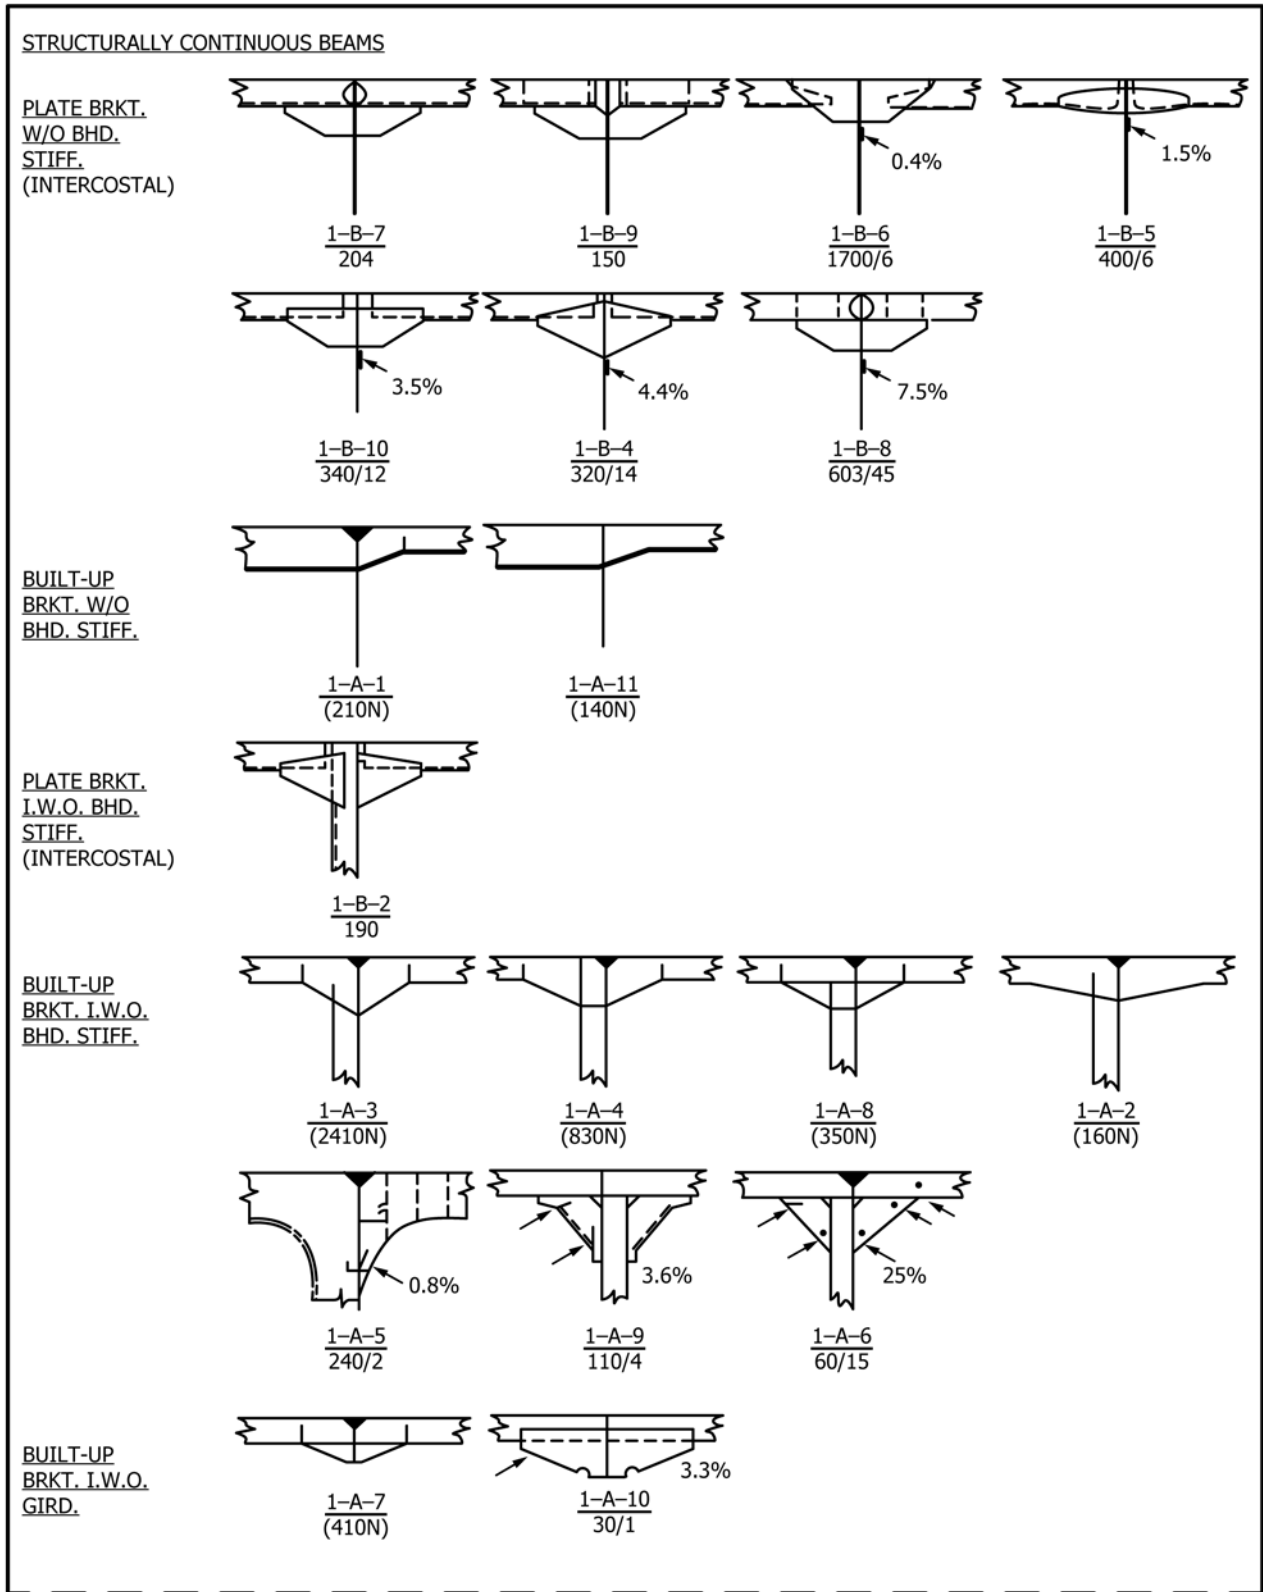
FIG. 14 Performance of Beam Bracket Details (Family No. 1)

4.1.1.3 In the beam bracket configurations of Family No. 1 (Fig. 14), 20 % of the surveyed failures attributed to design were caused by instability of the plate bracket edge or by instability of the plate bracket panel. This elastic instability, which resulted from loads that produce critical compressive or shear stresses, or both, in unsupported panels of plating, can be eliminated when properly considered in the design process.

4.1.1.4 The failures of beam brackets by cracking occurred predominately where face plates had been sniped, at the welded connections, at the ends of the brackets, at cutouts in the brackets, and where the brackets were not properly backed up at hatch ends. The sniping of face plates on brackets prevents good transition of stress flow, creates hard spots and produces fatigue cracks due to the normally cyclic stresses of these members. Care must be taken to ensure proper transition with the addition of chocks, back-up structure, reinforcement of hole cuts, and the elimination of notches.

4.1.5.3 The most prominent detail failures attributed to operations were to Family No. 1 beam brackets, (Fig. 14). Of the beam bracket failures 67 % were attributed to operation (heavy weather). Possible fixes for the beam brackets included

the use of face plates or panel stiffeners to increase panel stability, the use of heavier plating to increase the corrosion margin and increase panel stability, and the elimination of the indiscriminate use of lighting holes and miscellaneous cutout in areas subject to potentially high operational loading.

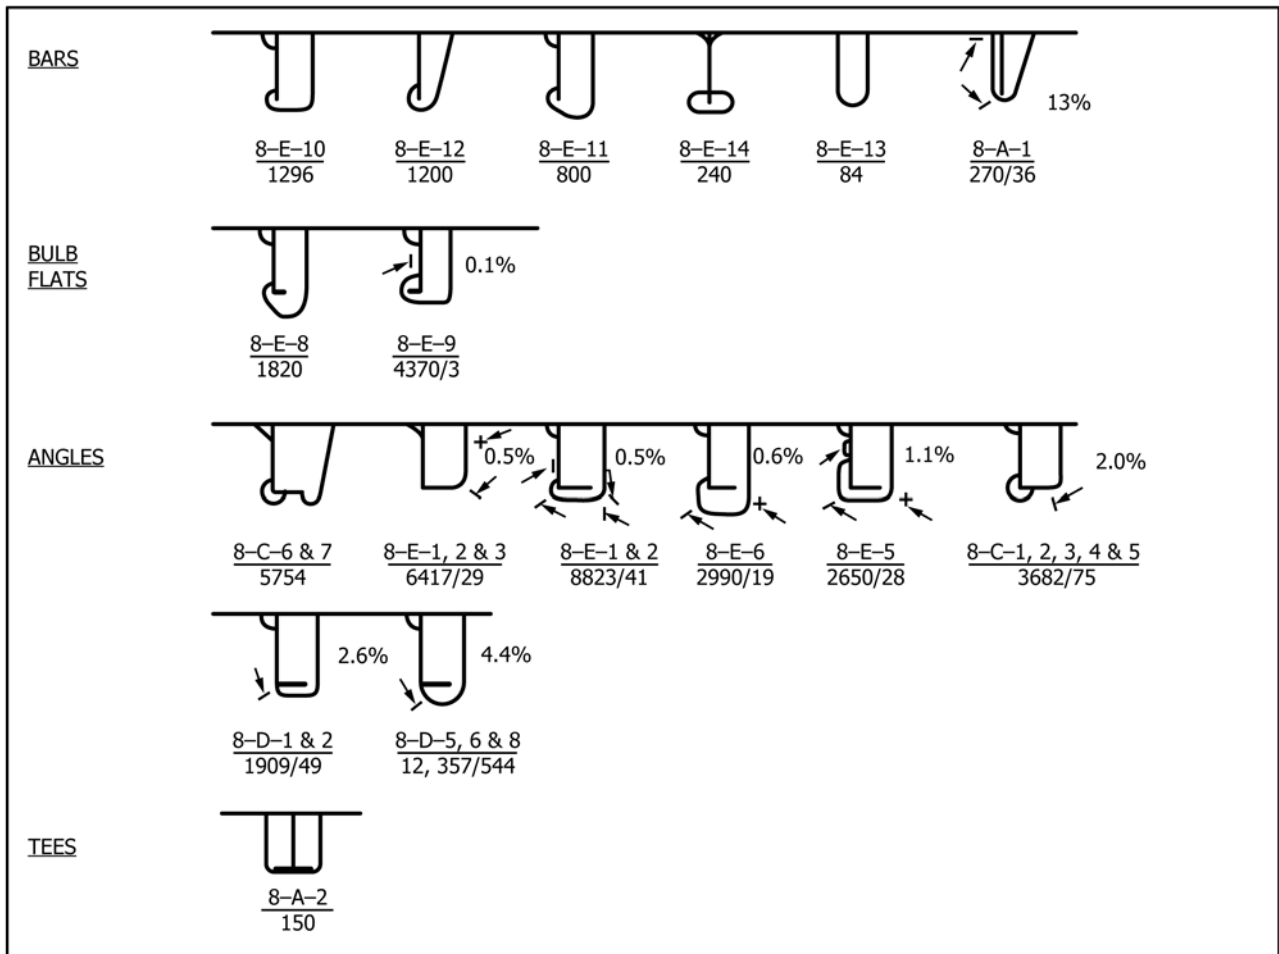
FIG. 16 Performance of Stiffener Clearance Cutout Details (Family No. 8)

4.1.1.11 The clearance cutouts of Family No. 8 (Fig. 16) are basically non-tight collars without the addition of the collar plate. Suggestions made for non-tight collars and miscellaneous cutouts are applicable for this family.

4.1.1.12 Well rounded corners with radii equivalent to 25 % of the width perpendicular to the primary stress flows should be used. Special reinforcements in the form of tougher or higher strength steel, inserts, coamings, and combinations of the above should be used where fatigue and high stresses are a problem.

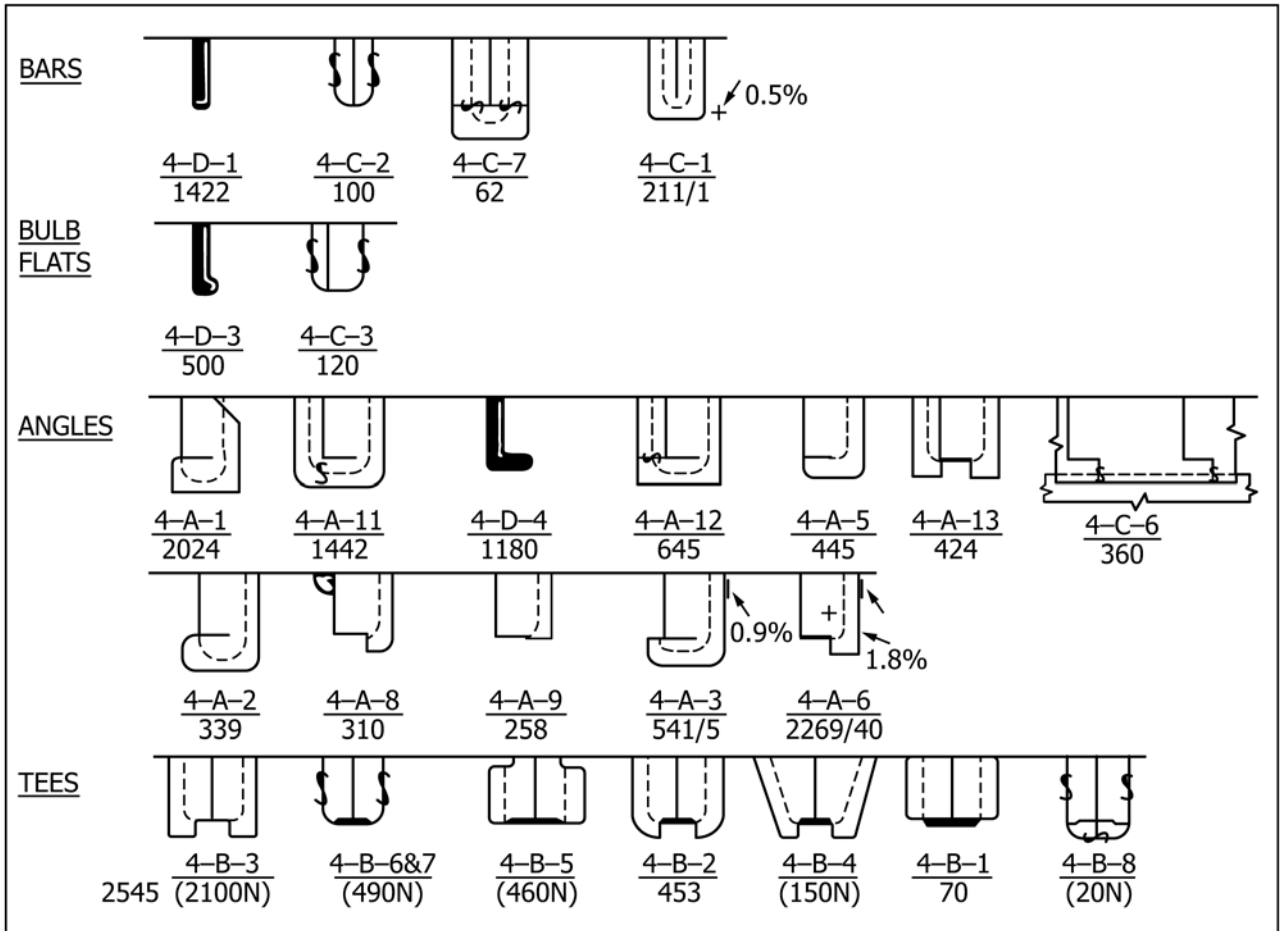
FIG. 18 Performance of Tight Collar Details (Family No. 4)
