Standard Guide for Identification of Structures and Contaminants Seen on Specular Silicon Surfaces¹

This standard is issued under the fixed designation F 154; the number immediately following the designation indicates the year of original adoption or, in the case of revision, the year of last revision. A number in parentheses indicates the year of last reapproval. A superscript epsilon (ε) indicates an editorial change since the last revision or reapproval.

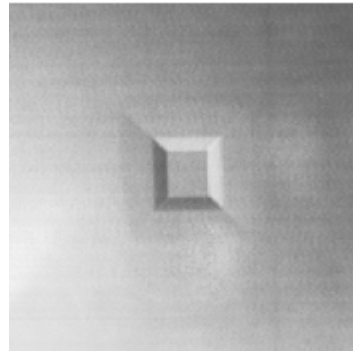
FIG. 9 Epitaxial Growth Hillock on (100), No Preparation Required, Size Dependent Upon EPI Thickness.

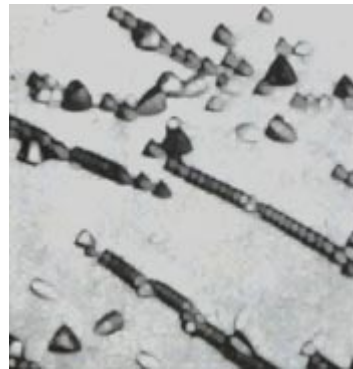
FIG. 11 Lineage on (111) Silicon Following Preferential Etch, Magnification 140 \times .

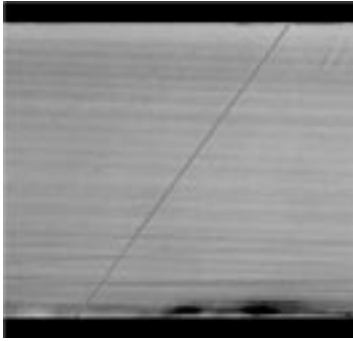
FIG. 30 Twin Lamella in a $\langle 110 \rangle$ Cleaved Vertical Cross Section Following 2.6 micron Removal in Leo (Modified Sirtl) Etch.

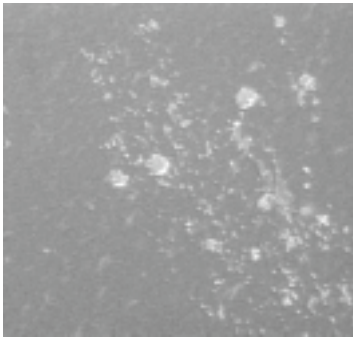
FIG. 31 Area Contamination, Magnification 100 \times .

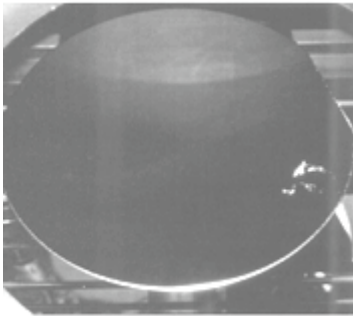
FIG. 32 Area Contamination Seen With a High Intensity Light Source, Full Wafer View.

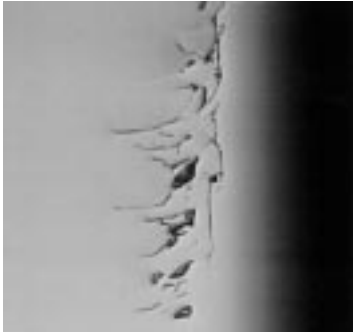
FIG. 36 Crack Near the Edge of a Wafer Surface Due to Mechanical Contact, No Preparation Required, Magnification 750 \times .

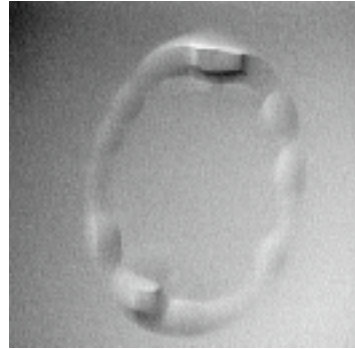
FIG. 39 Crater, Usually Caused by Inadequate Rinse of Polishing Chemicals, Magnification 50 \times .

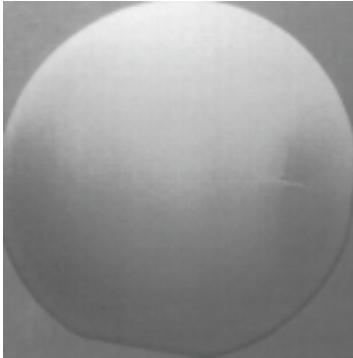
FIG. 37 Cracks in a Wafer Surface Viewed with High Intensity Light Exhibiting a Scratch-Like Appearance.

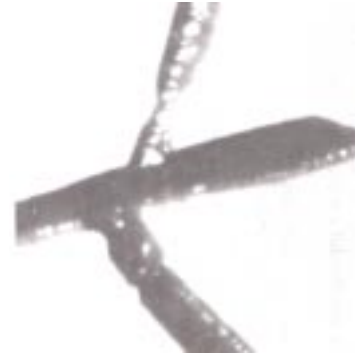
FIG. 40 "Crows-Foot" Crack Resulting from the Impact of a Hard Object with the Wafer Highlighted by Preferential Etch, Magnification 300 \times .

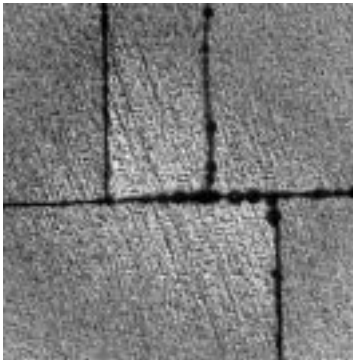
FIG. 38 Cracks in an Etched Wafer Surface, Magnification 38 \times .

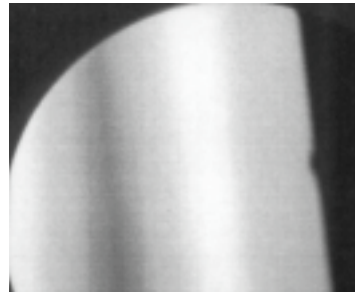
FIG. 41 Dimples Under Fluorescent Lighting Conditions Distort the Reflected Image.

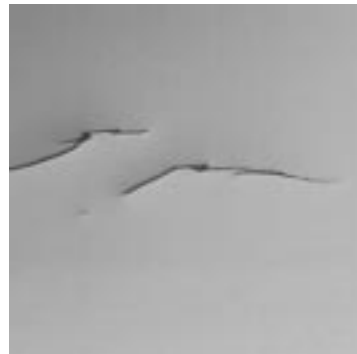
FIG. 44 Relatively Large Chip Found at the End of a Major Flat, No Preparation Required, Magnification 37 \times .

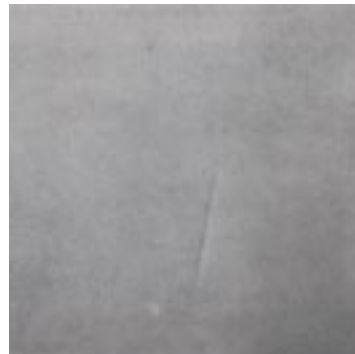
FIG. 50 Epitaxial Large Point Defect, No Preparation Required, Magnification 200 \times .

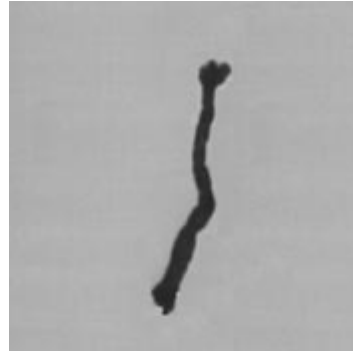
FIG. 54 Groove or Micro-Scratch, Magnification 220 \times .

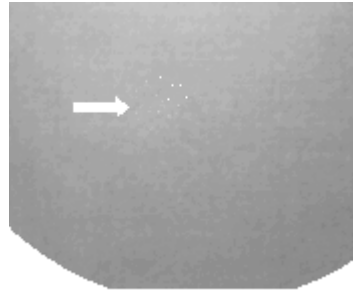
FIG. 55 Haze Seen as Distortion or Blurring of a Reflected Image, Full Wafer View.
