**Plain bearings — Appearance and  
characterization of damage to metallic  
hydrodynamic bearings —**

**Part 1:  
General**

Reference number  
ISO 7146-1:2008(E)

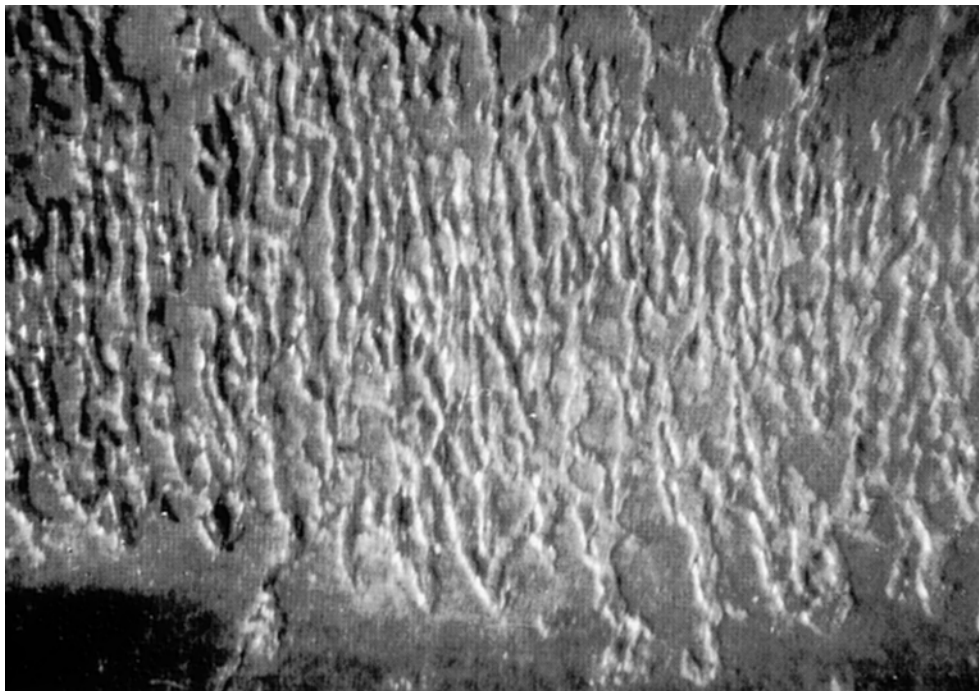
direction of shaft rotation →

b) section from Figure 7 a) showing the lower half at increased magnification

**Figure 7 — Cracks in the electroplated overlay (material: steel/lead bronze/electroplated overlay)**

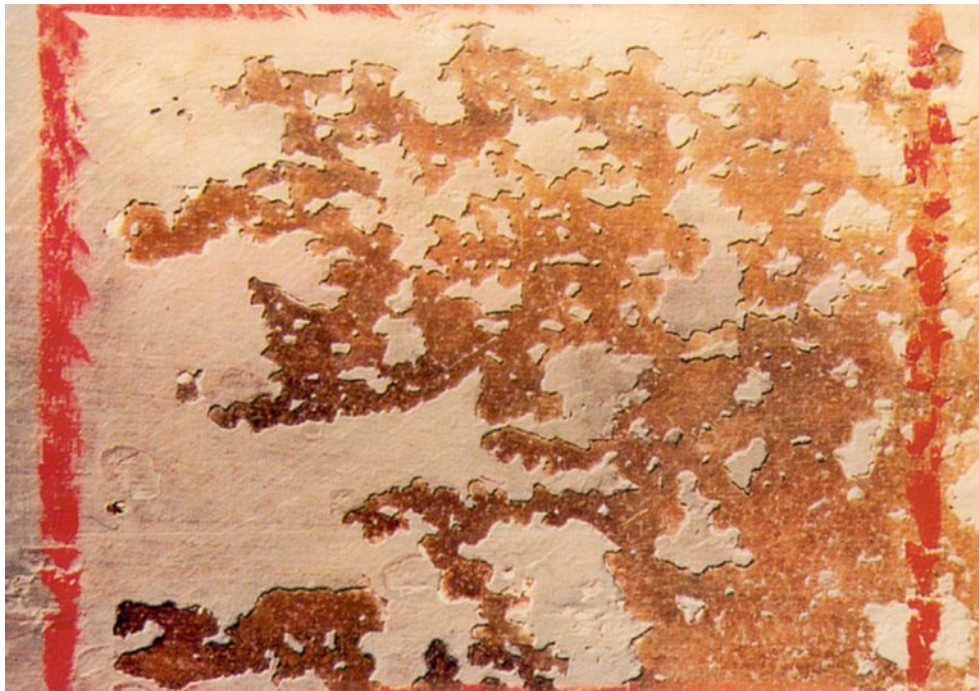
b) section from Figure 12 a): clear illustration of the defect at increased magnification

**Figure 12 — Detachment of the overlay leaving occasional residual islands relieved by a dark background (material: steel/lead bronze/electroplated overlay)**

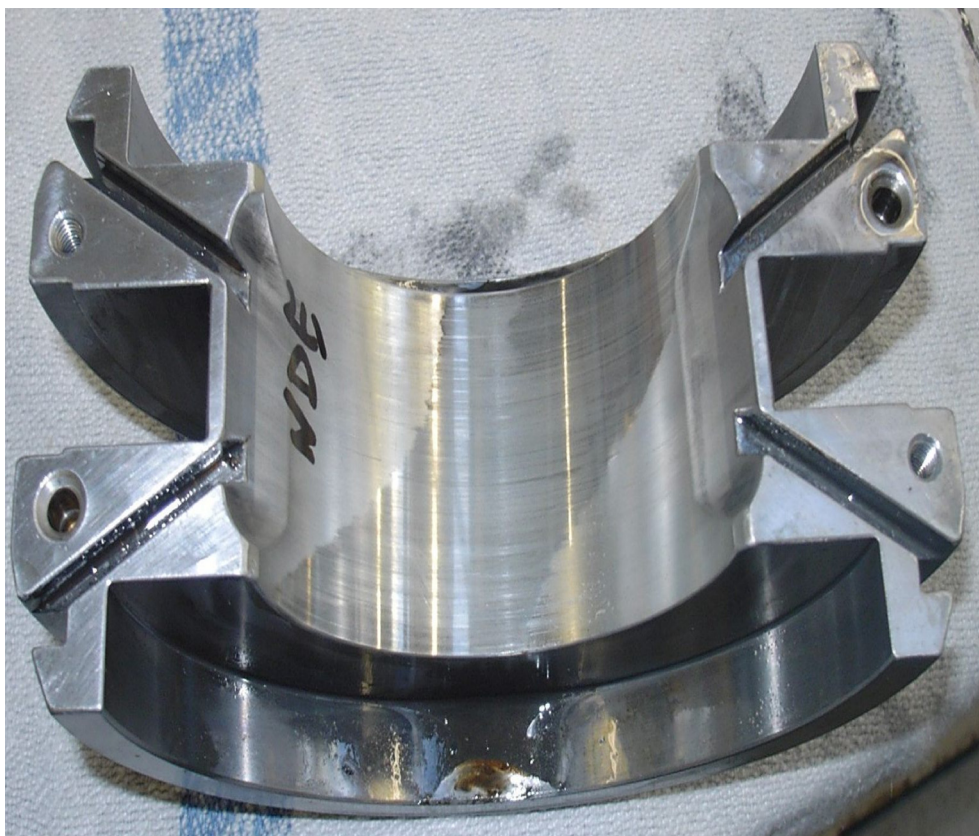
**Figure 17 — Wear by misalignment between bearing backing and shaft (material: steel/tin-based white metal)**

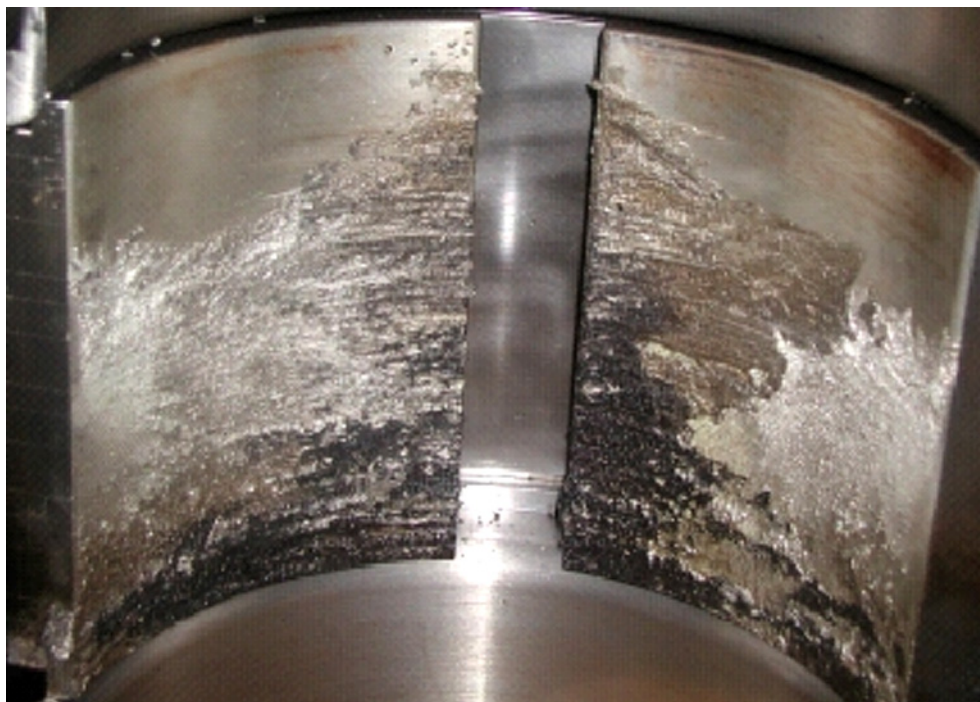
**Figure 27 — Coloured surface due to loss of lubricant, melting out, seizure  
(material: steel/tin-based white metal)**

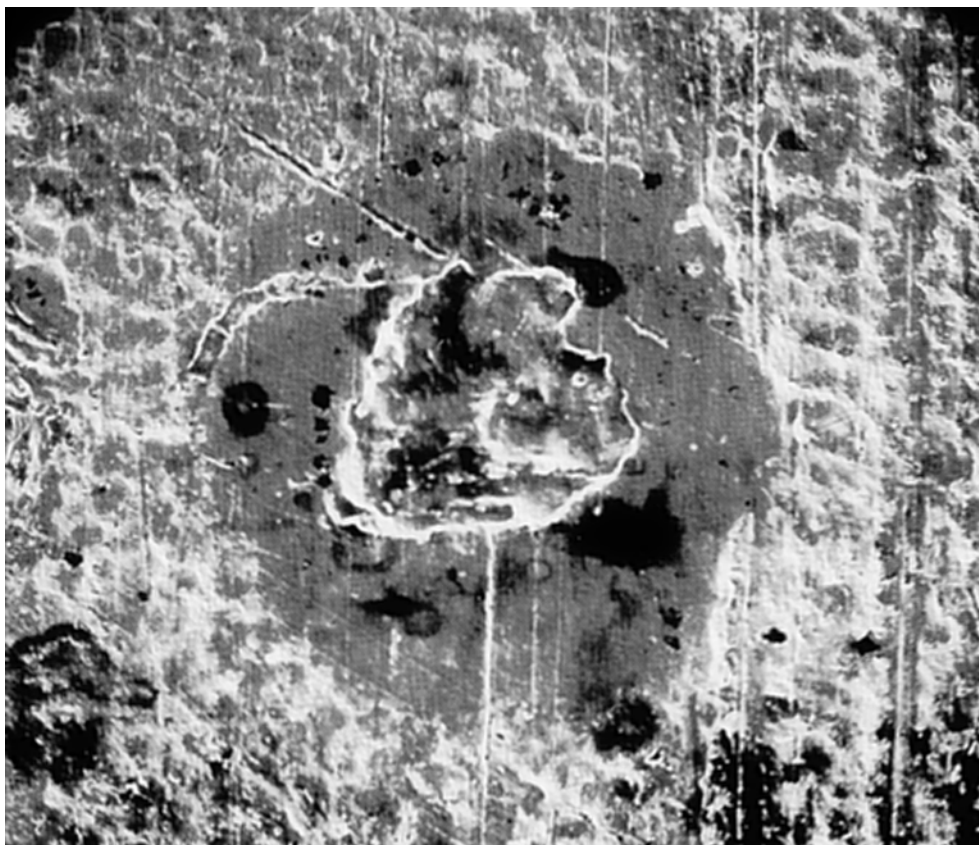
**Figure 30 — Crater left by displaced particle surrounded by reflective ring (halo), characteristic of embedding, see Figure 28, label 6, (material: steel/lead bronze/electroplated overlay)**

Particles embedded in the bearing surface, surrounded by raised bearing metal displaced as the particle is embedded. The raised bearing metal appears as a highly reflective halo around the embedded particle (see Figure 30). The halo comes in contact with the counterface. Traces of mixed lubrication and worn material occur.

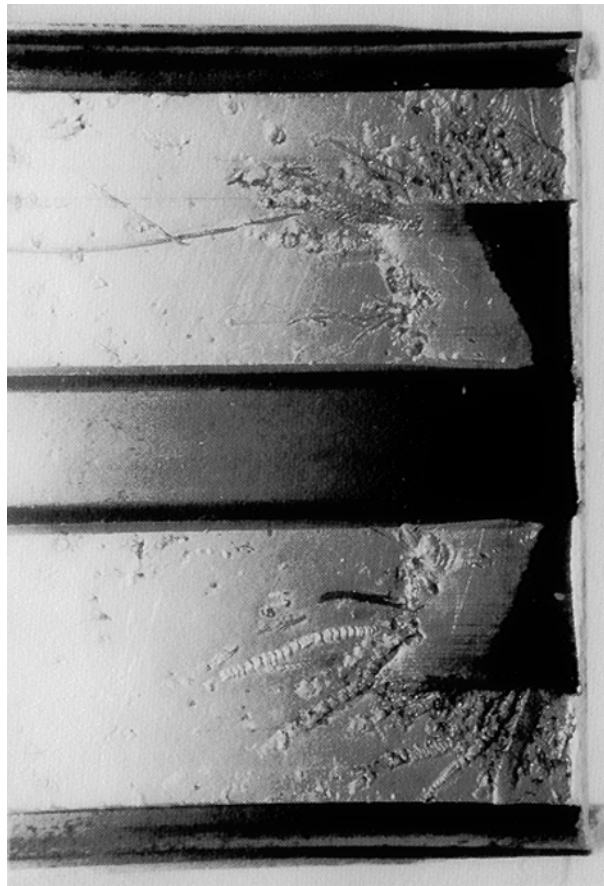
← direction of shaft rotation

**Figure 34 — Particle-migration tracks concentrated to the pocket area of a thin-walled bearing (material: steel/AlSn)**

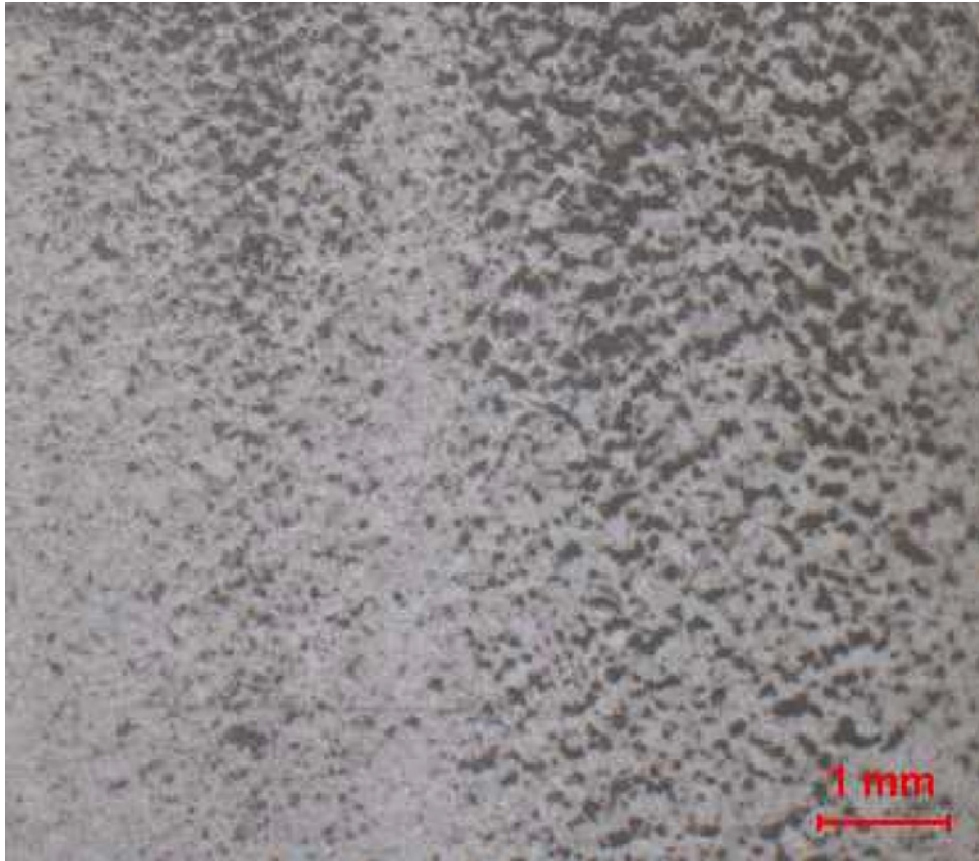
Figure 42 — Deposit of oil carbon on galvanic surface

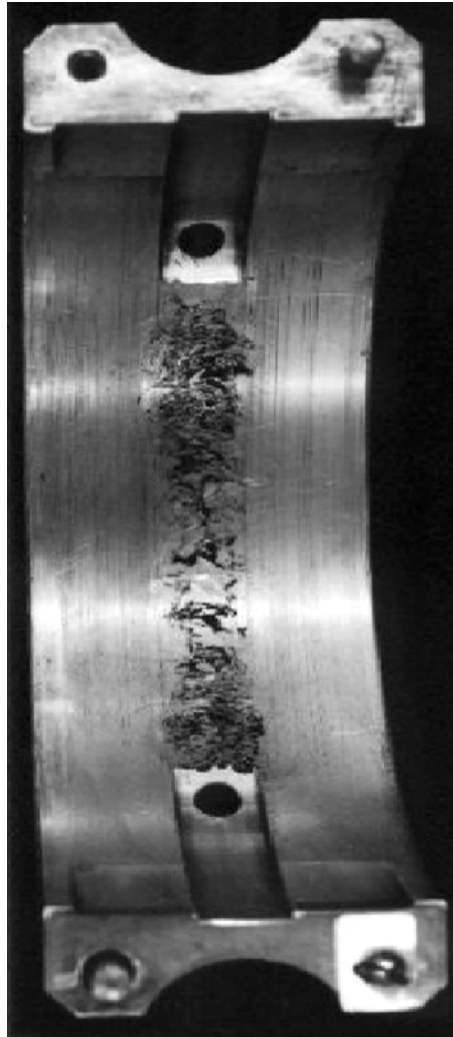
Figure 43 — Typical cavitation erosion on a thick-walled bearing (material: steel/tin-based white metal)

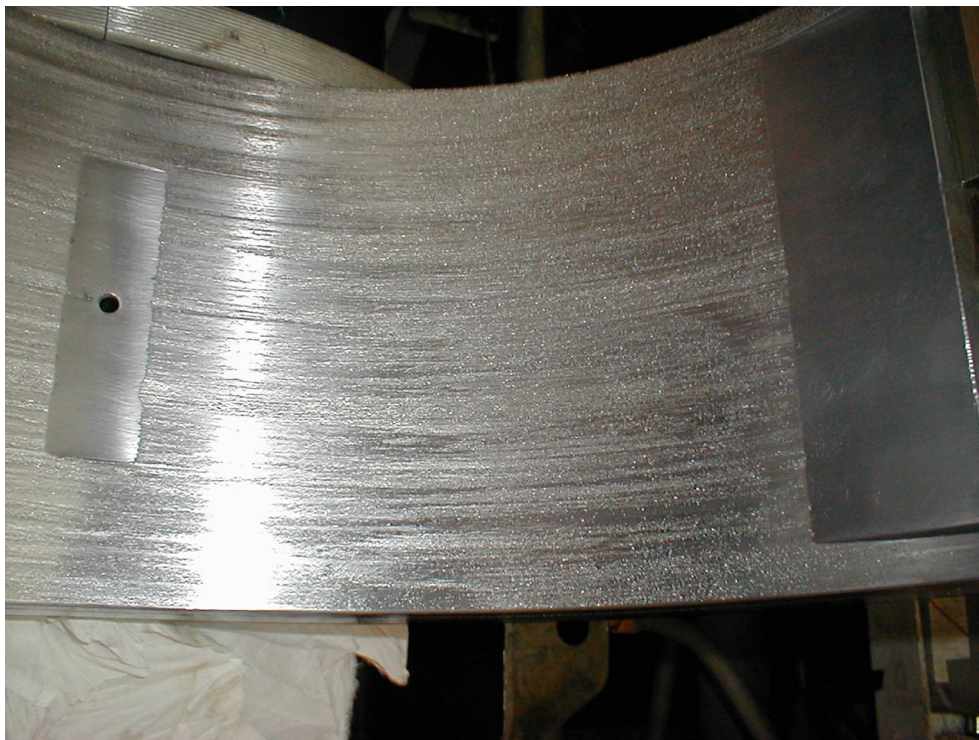
**Figure 46 — Formation of electric arc craters**
