Designation: F1057 – 17

Standard Practice for Estimating the Quality of Extruded Poly (Vinyl Chloride) (PVC) Pipe by the Heat Reversion Technique¹

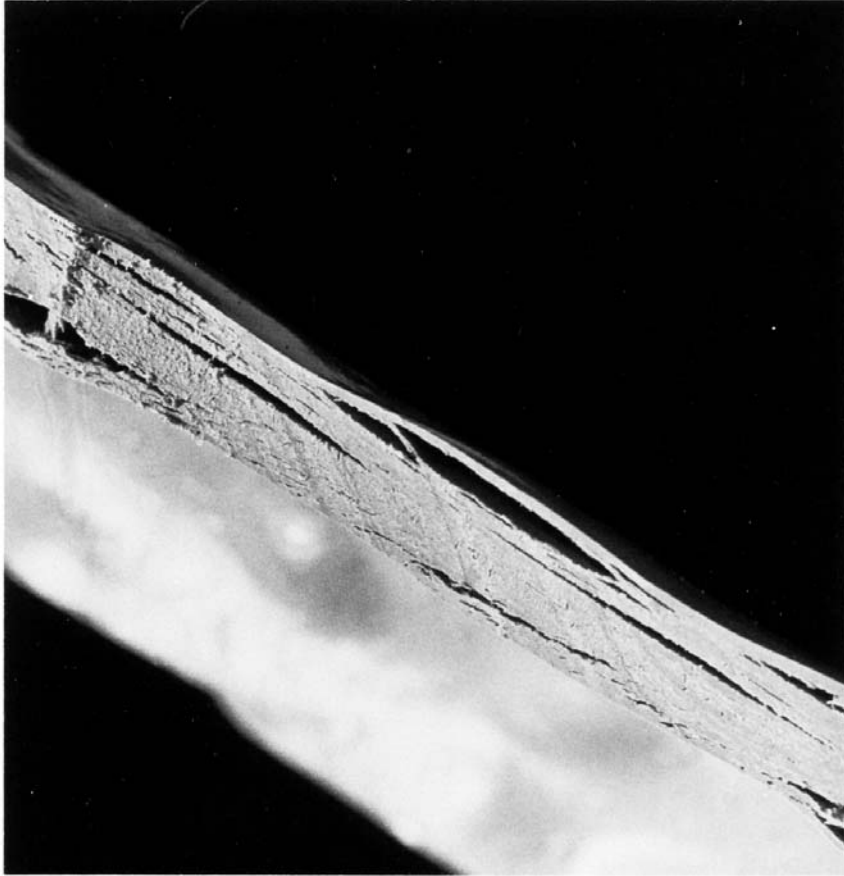
FIG. X1.2 Severe Wall Separation

NOTE 1—Severe wall separation reveals the presence of moisture in the extrudate. This usually indicates plugged or inadequate vacuum control.

X1.1.2 Evidence of the incomplete exsiccation of compound before or during extrusion, appearing as wall separation (see [Fig. X1.2](#) and [Fig. X1.3](#) for illustrations of wall separation);
