**Rolling bearings — Damage and failures  
— Terms, characteristics and causes**

**ISO**  
**15243**

Second edition  
2017-03

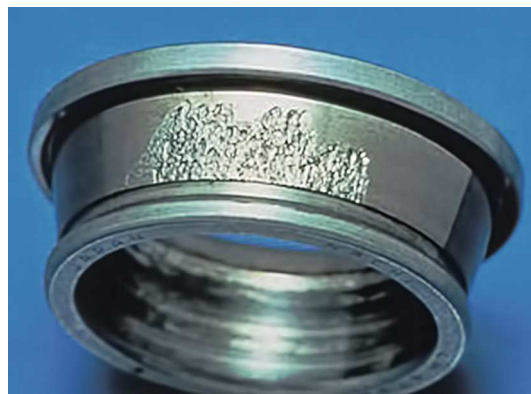
Figure 4 — Advanced subsurface spalling in a tapered roller bearing — Stationary inner ring

The changes might appear at metallurgical investigation (see [A.3](#)). These cracks propagate and when they come to the surface, spalling occurs (see [Figures 3](#) and [4](#)).

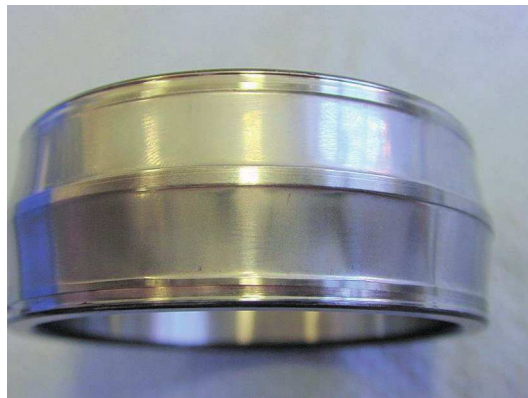
**Figure 8 — Abrasive wear on the inner ring of a spherical roller bearing**

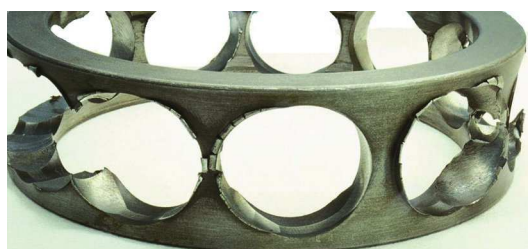
**Figure 9 — Advanced abrasive wear on the cage pockets of a solid metal cage**

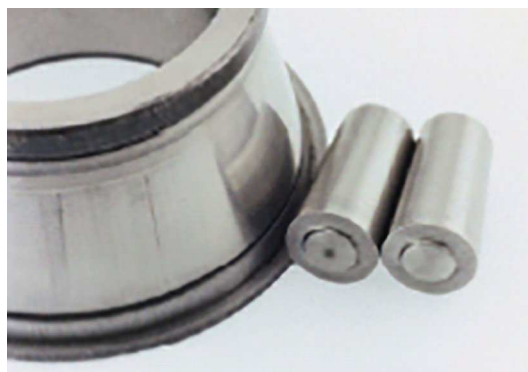
**Figure 10 — Abrasive wear on the raceway of the large rib surface of the inner ring and on the large end face of rollers in a tapered roller bearing**

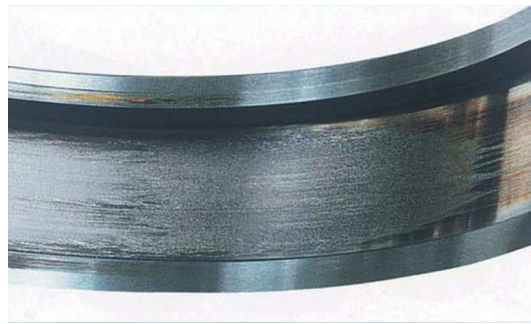
**Figure 11 — Smearing on the outer ring raceway of a cylindrical roller bearing**

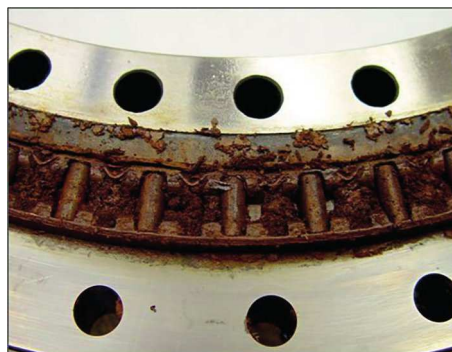
**Figure 14 — Moisture corrosion on the cage and rollers of a needle roller thrust bearing**

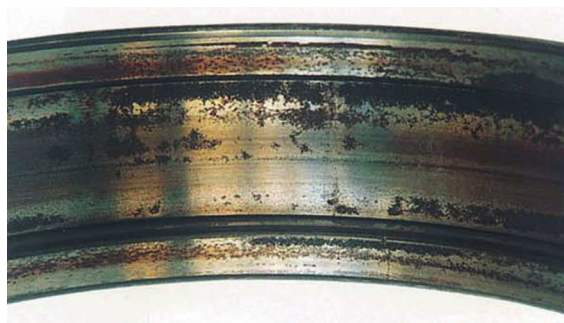
**Figure 15 — Moisture corrosion on the outer ring raceway of a cylindrical roller bearing**

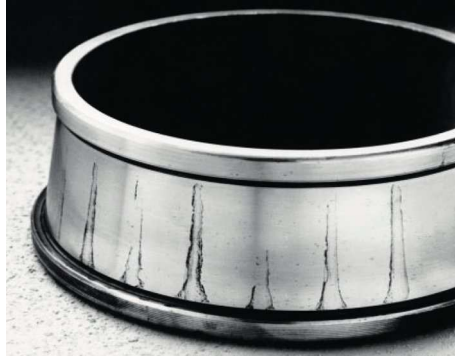
**Figure 16 — Contact corrosion at roller pitch on the inner ring raceway of a tapered roller bearing**

A specific form of moisture corrosion can be observed in the contact areas between rolling elements and bearing rings where the water content in the lubricant or the degraded lubricant reacts with the surfaces of the adjacent bearing elements. During static periods, the advanced stage will result in dark discolouration of the contact areas at intervals corresponding to the ball/roller pitch (see [Figure 16](#)); eventually producing corrosion pits.

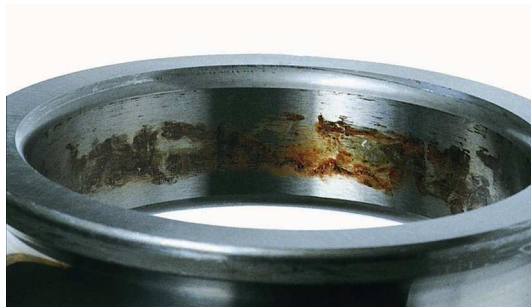
**Figure 17 — Fretting corrosion in the inner ring bore of a deep groove ball bearing**

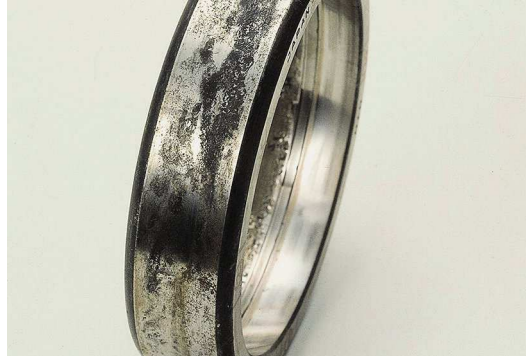
**Figure 18 — Fretting corrosion on the outer diameter of a roller bearing**

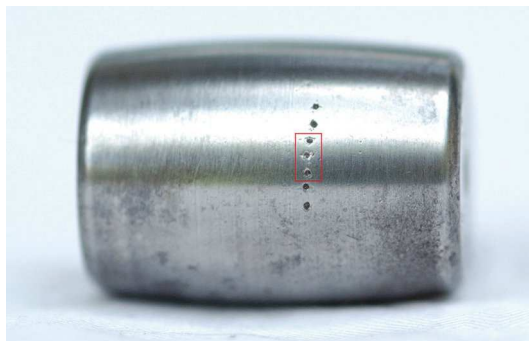
**Figure 21 — Roller of a spherical roller bearing — Craters formed by the passage of excessive electric current**

This damage (electrical pitting) may appear as a series of craters with diameters of up to 500  $\mu\text{m}$  (see [Figures 21](#) and [22](#)). The craters are duplicated on the rolling element and raceway contact surfaces, typically in bead-like procession in the rolling direction (see [Figure 21](#)).

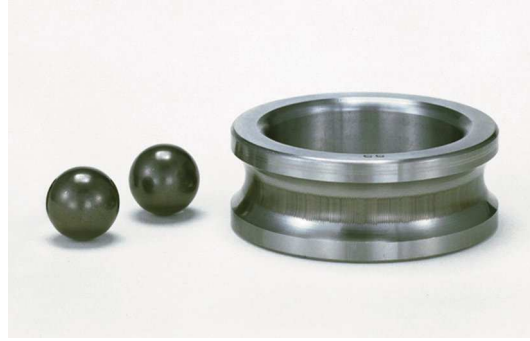
**Figure 24 — Fluting on the inner ring raceway and matt dark grey coloured balls of a deep groove ball bearing**

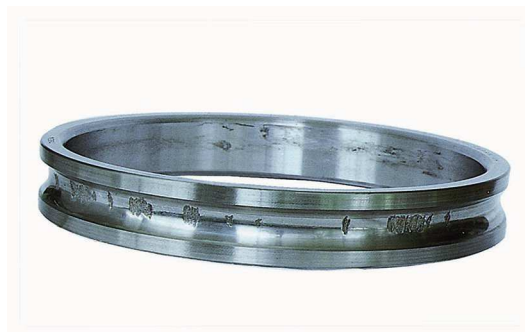
**Figure 27 — Spalling as a result of shock load deformation on the inner ring raceway of an angular contact ball bearing, resulting from impacts in radial direction, which further developed in spalling**

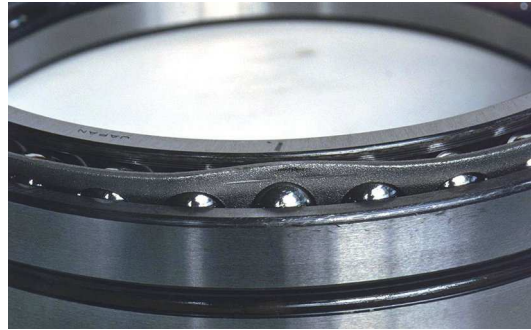
**Figure 28 — Cage deformation of an angular contact ball bearing caused by a shock load during handling**

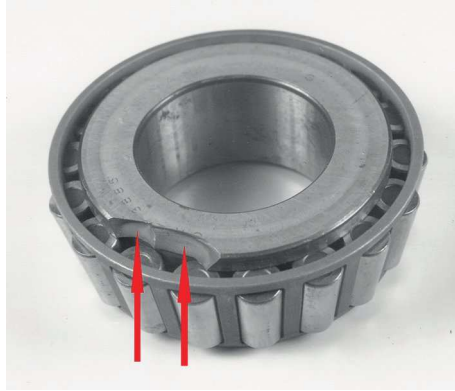
**Figure 33 — Forced fracture of a tapered roller bearing inner ring shoulder, caused by an impact load during assembly procedures**

Forced fracture is due to a stress concentration in excess of the material (tensile) strength and is caused by local over-stressing, e.g. from impact (see [Figure 33](#)), or by over-stressing due to an excessive interference fit, e.g. too high hoop stress (see [Figure 34](#)).

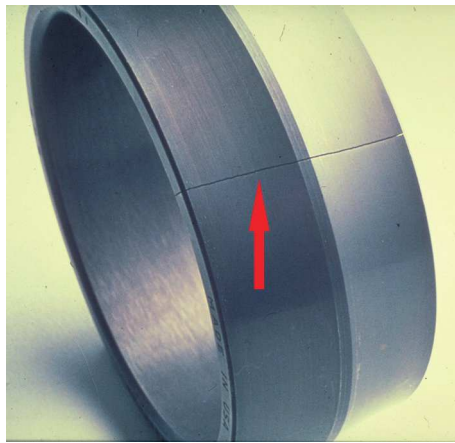
NOTE Fracture caused by an excessive interference fit during mounting, for example, by driving a tapered bore inner ring too far up the shaft taper.

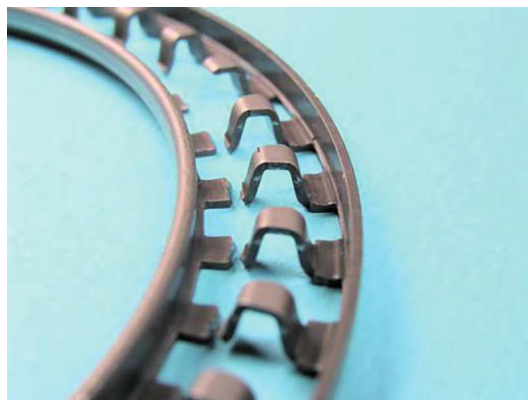
**Figure 36 — Fatigue fracture of cage bars of a needle roller thrust bearing**

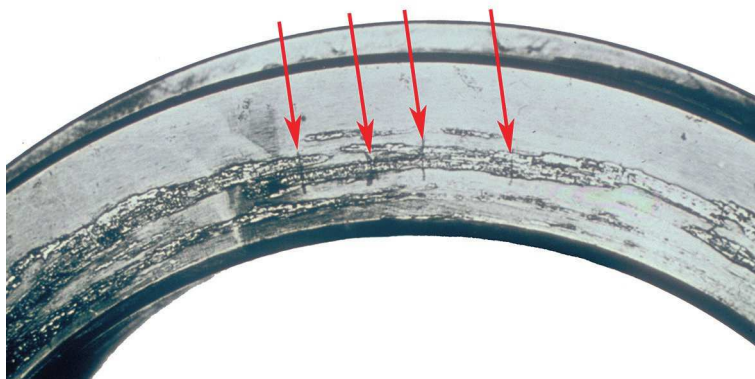
**Figure 37 — Thermal cracks on the small end of the inner ring of a tapered roller bearing**

Thermal cracking (heat cracking) is caused by high frictional heating due to sliding motion. Cracks usually appear at right angles to the direction of sliding (see [Figure 37](#)). Hardened steel components are generally sensitive to thermal cracking due to local rehardening of the surfaces in combination with the development of high residual tensile stress.
